Wadebridge School  
Gonvena Hill  
Wadebridge  
Cornwall  
PL27 6BU

## Asbestos Refurbishment Survey Report

Report No: J001336  
UPRN: 4153  
Engineering Services Laboratory

The survey was undertaken prior to re-roofing part of Block 1.

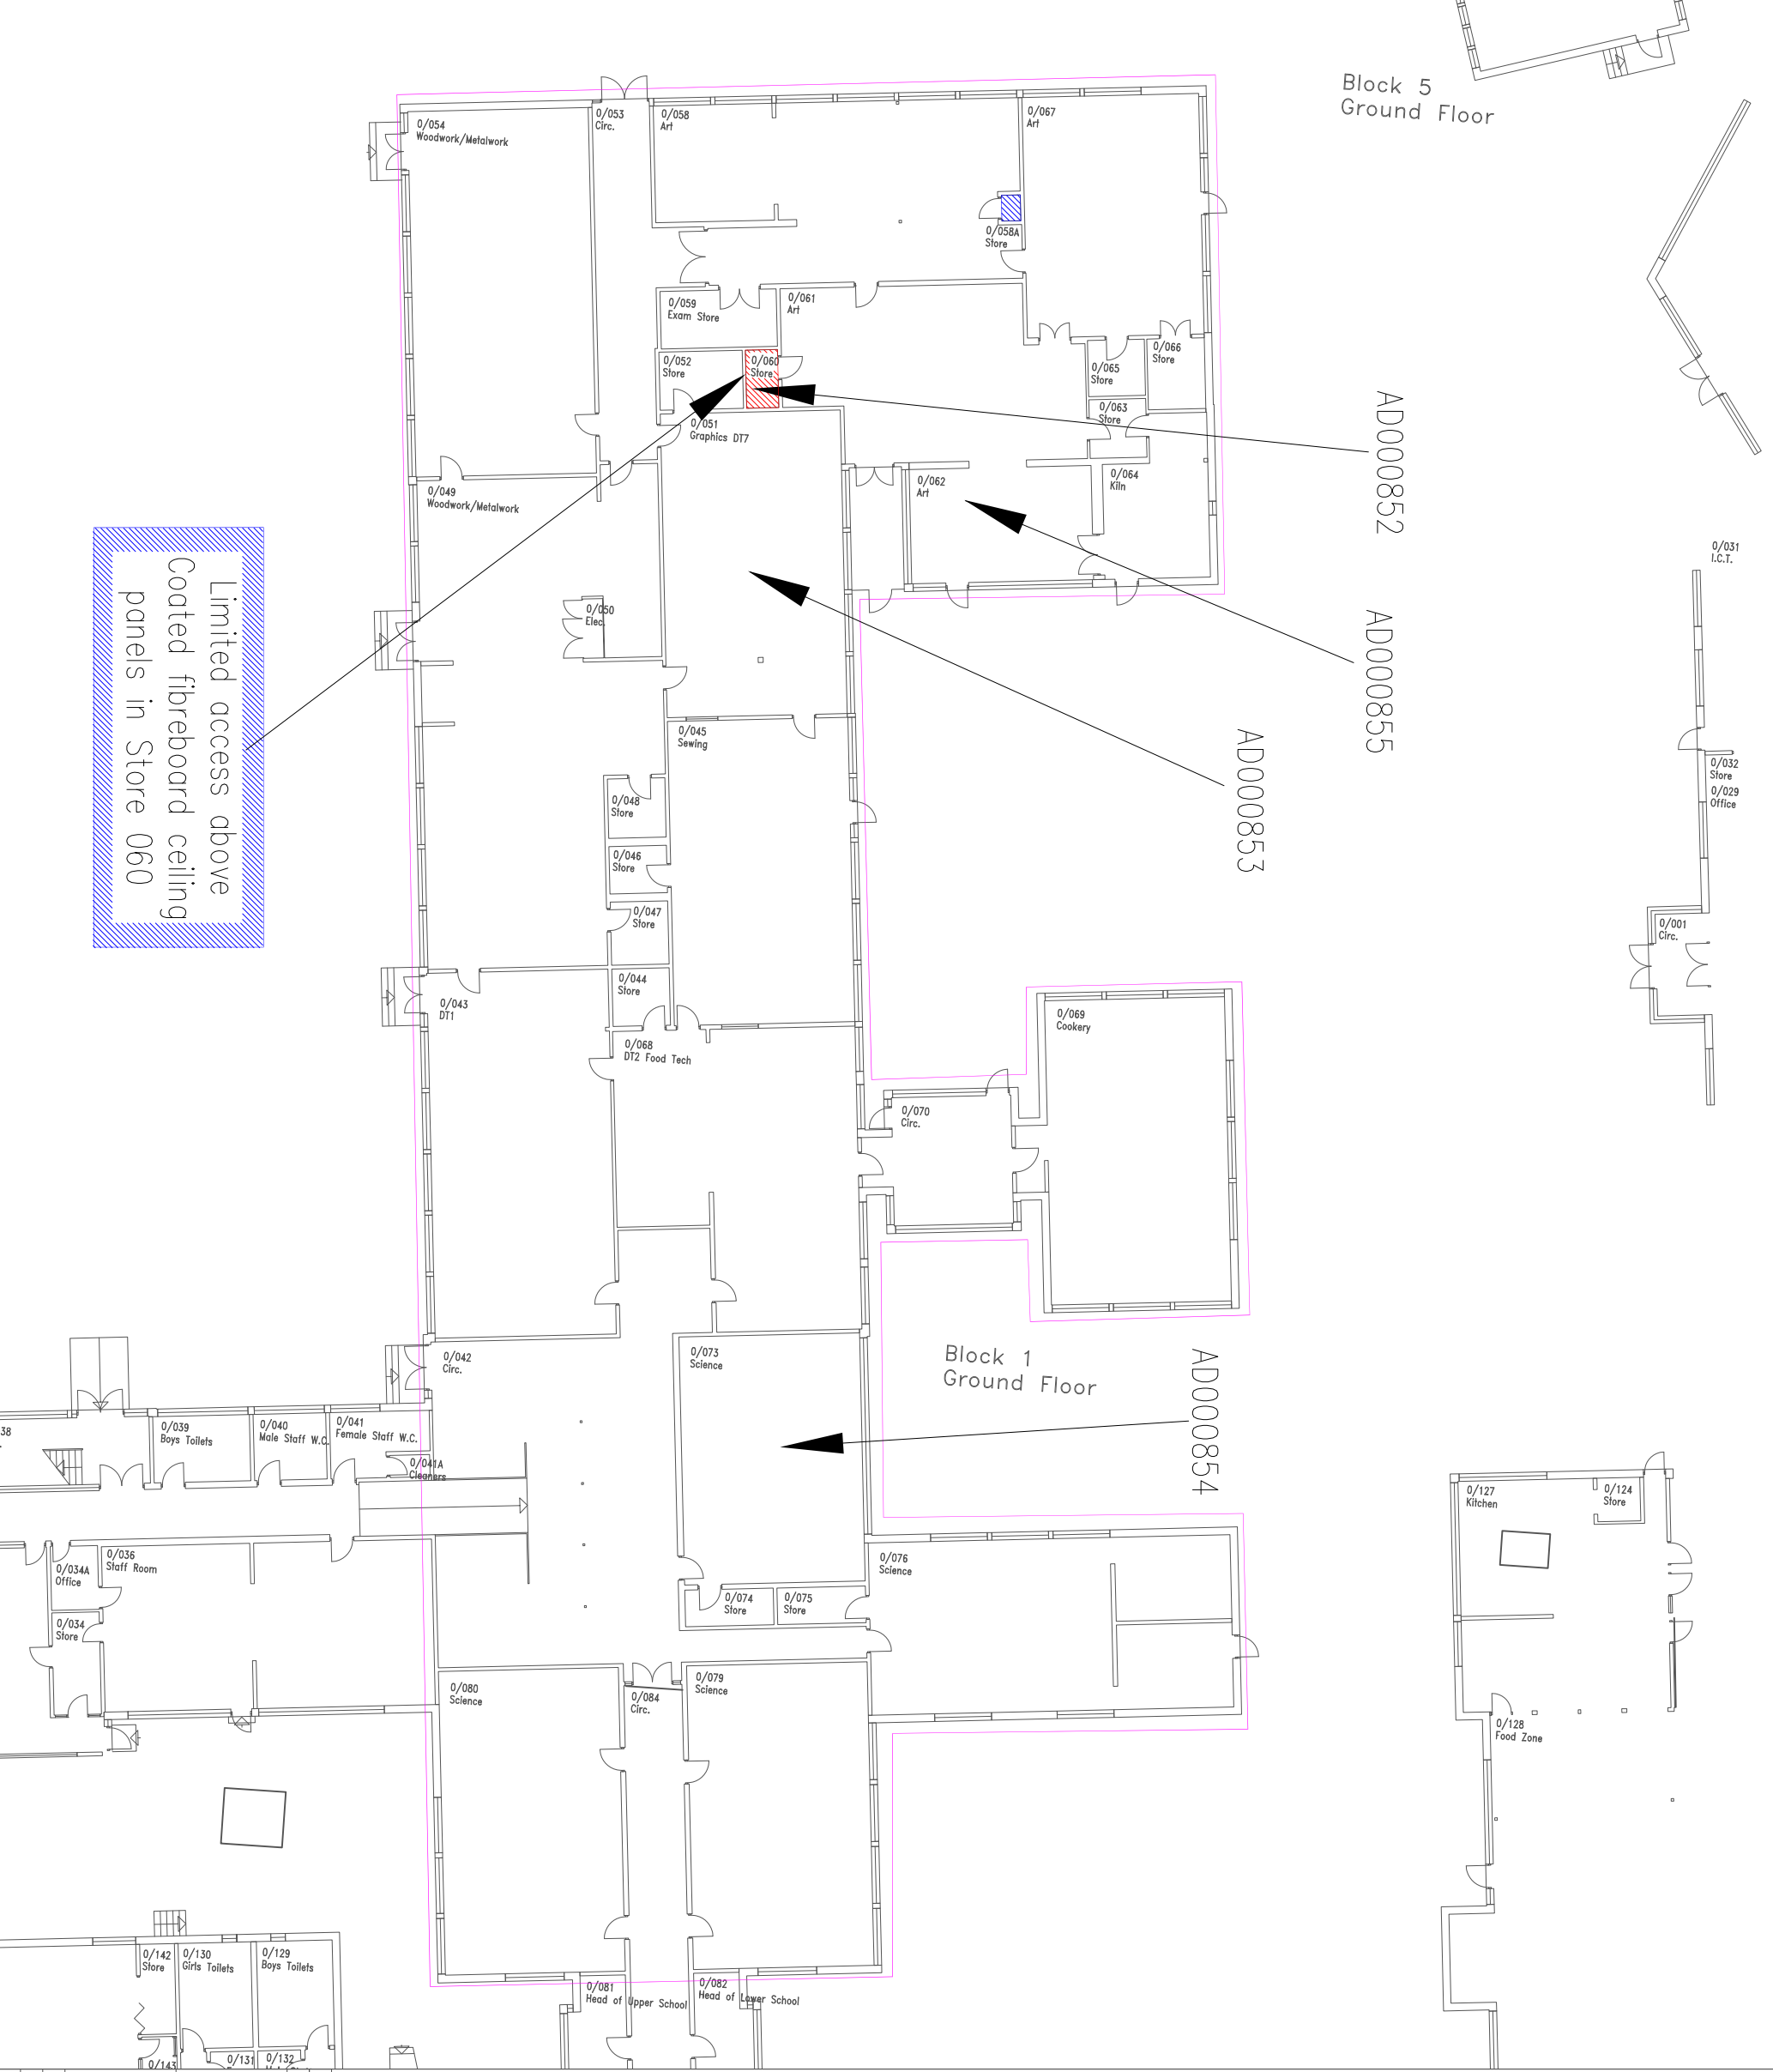
Access was not possible above the fixed ceiling in Store 058A.

Limited access above  
Coated fibreboard ceiling  
panels in Store 060

It must be assumed that all inaccessible areas contain ACMs until proven otherwise. It is therefore recommended that the client should arrange access to any inaccessible areas encountered during the survey if they may be affected by the proposed work.

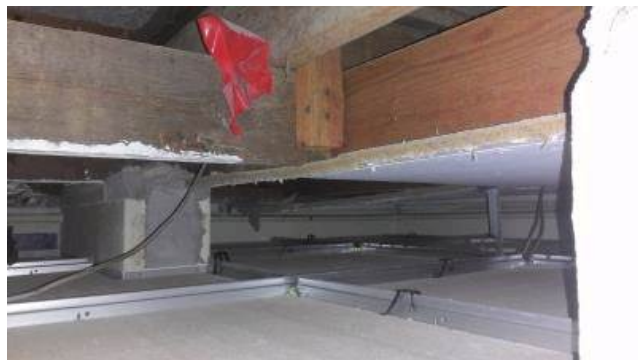
Asbestos was identified within the coated fibreboard ceiling panels in Block 1, Store 060.

It should be noted that the Coated fibreboard ceiling panels within Block 1, Store 060 were found to have medium damage.

B	F	R	Room Description	Sample Ref. No:	Material Location	Approx. Quantity (m <sup>2</sup> )	Product Type	Asbestos Type	Surface Treatment	Condition	Material Assem't Score	Accessibility	Comments
1	0	060	Store	AD000852	Coated fibreboard ceiling panels in void above suspended ceiling	2m <sup>2</sup>	Asbestos Insulating Board	Chrysotile	Unsealed	Medium Damage	7	Usually inaccessible or unlikely to be disturbed

Item NO: 17 Block No. 1  
Floor No. 0 Room No. 060  
Sample Reference: AD000852  
Description: Coated fibreboard ceiling  
panels in void above suspended  
ceiling

It should be noted that the coated fibreboard ceiling panels within Block 1, Store 060, Store were found to have medium damage, it is recommended that this material should be repaired and encapsulated if it does not require removal as part of the planned work.
