Wadebridge School  
Gonvena Hill  
Wadebridge  
Cornwall  
PL27 6BU

## Asbestos Refurbishment Survey Report

Report No: J003979  
Date Approved: 12 January 2018  
Revision: 0  
Engineering Services Laboratory

Scope of Work: Asbestos refurbishment survey to Junior Dining Room.

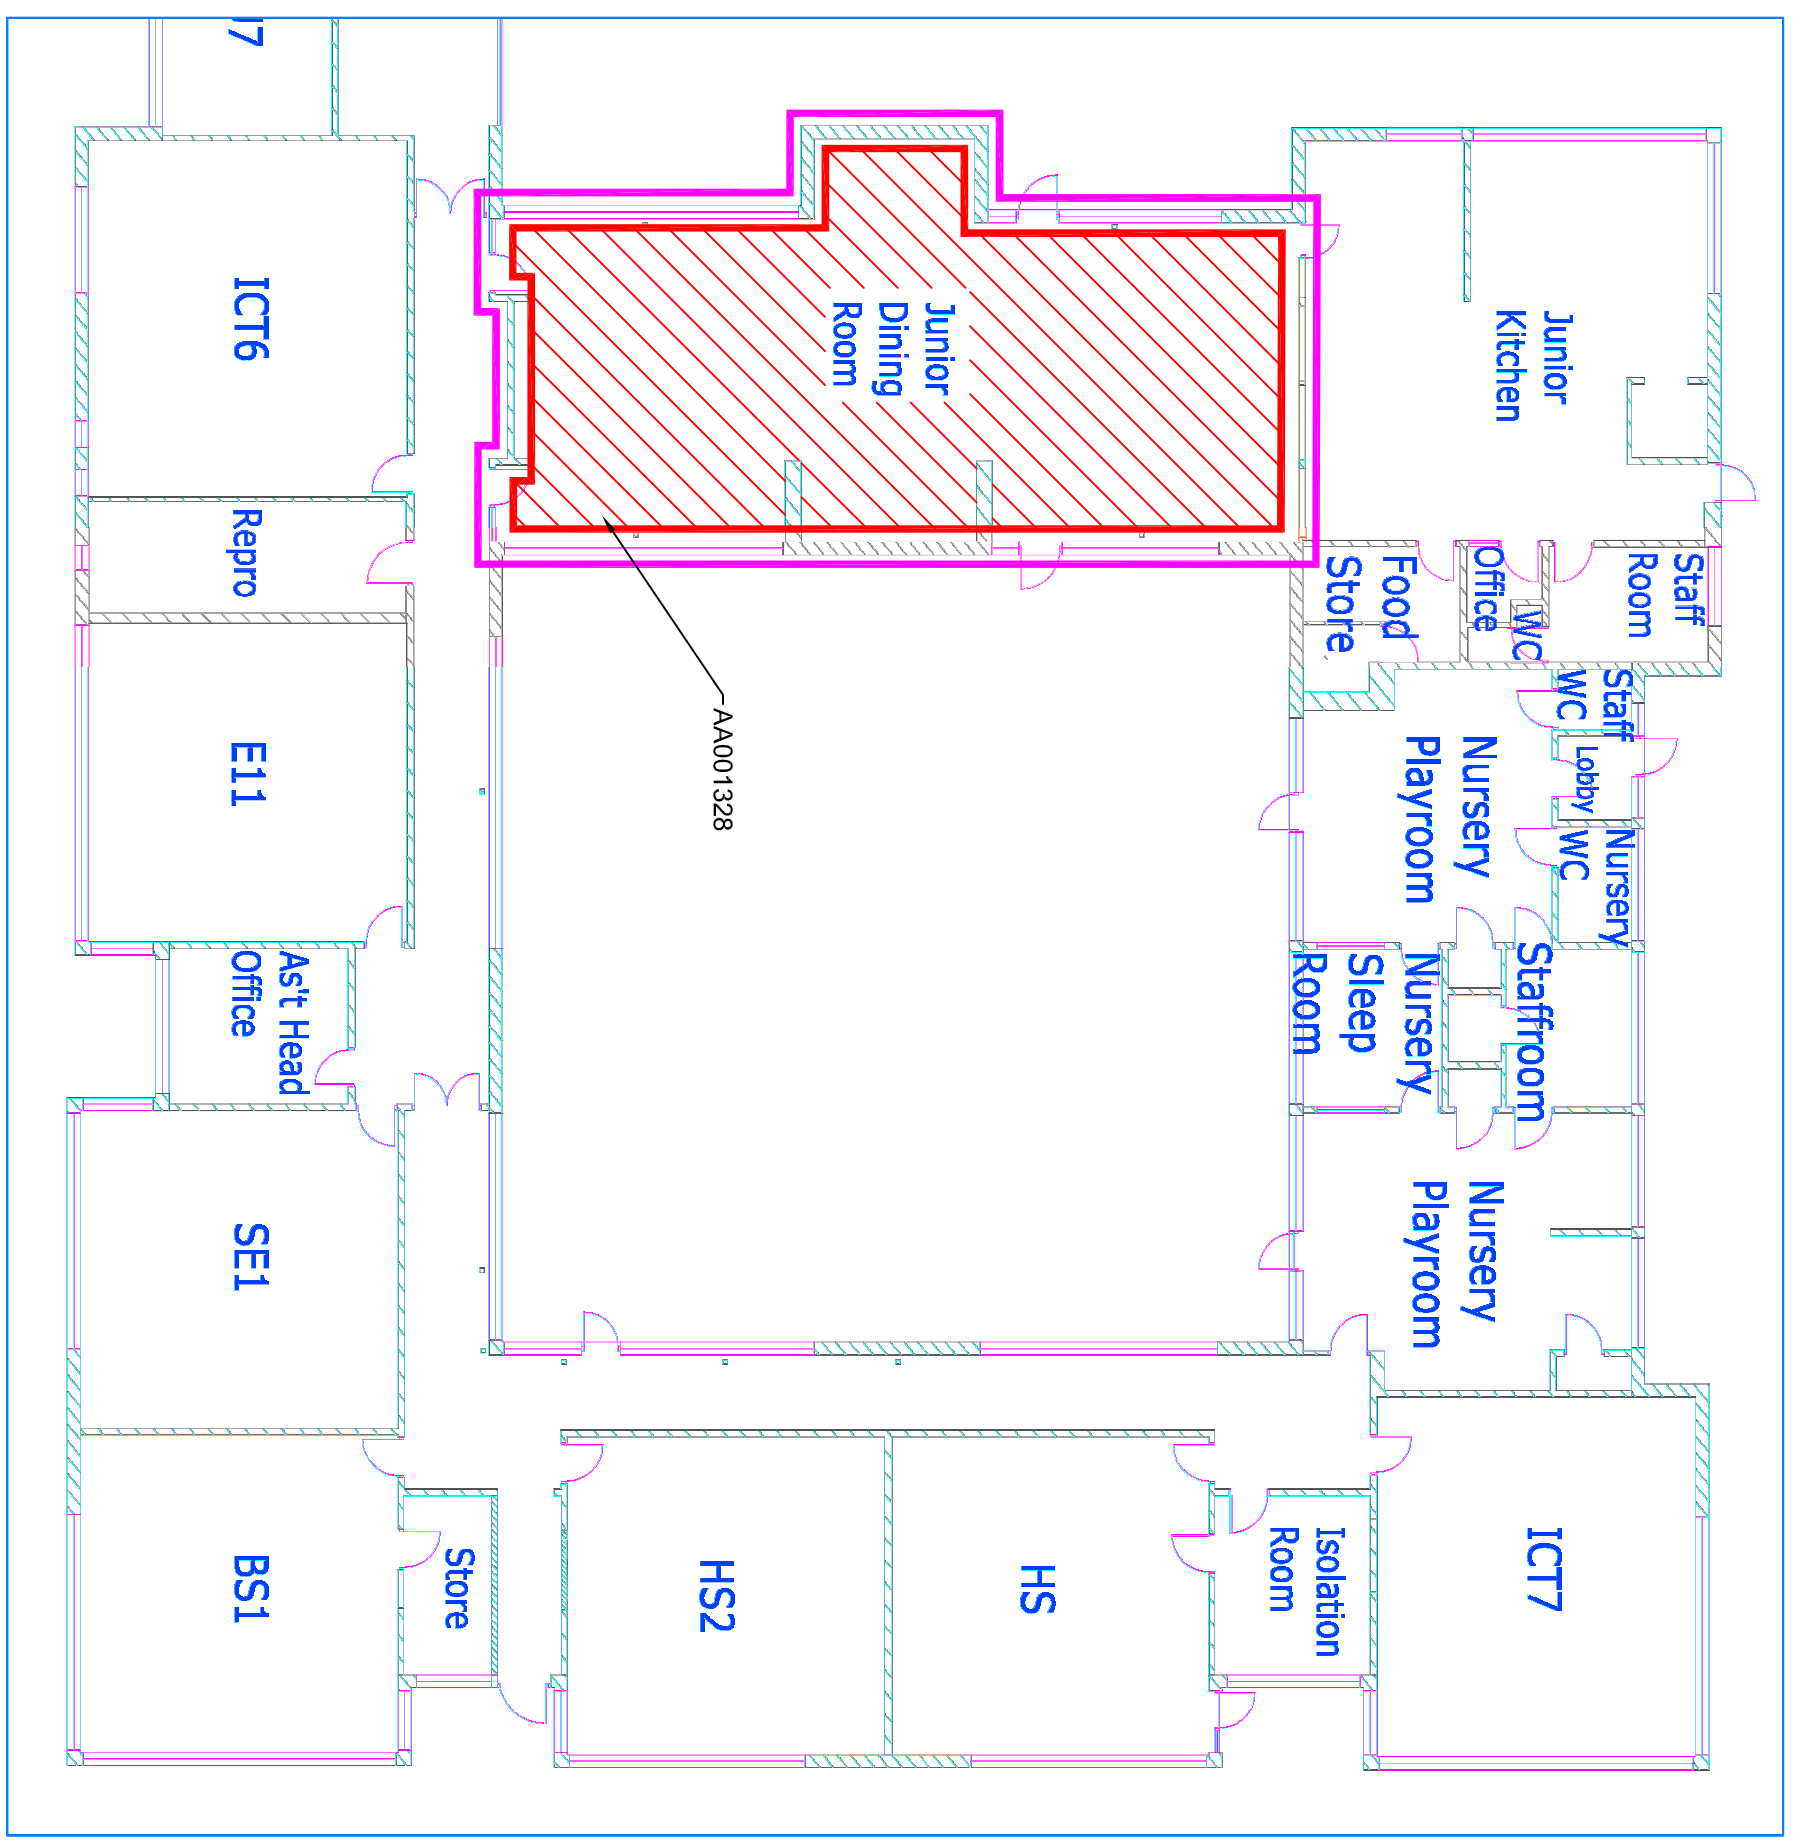
DRAWING TITLE:  
ACM Location Plan

Some bitumen packers have previously tested positive for asbestos in other parts of this building

See Executive Summary & register of findings for further details of all inaccessible areas

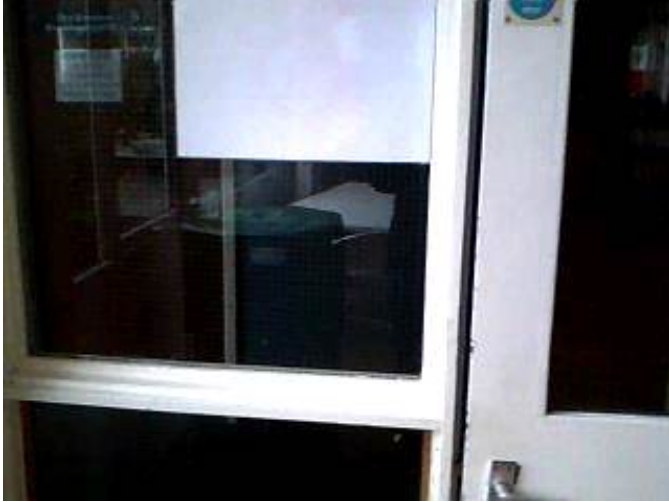
Item NO: 2 Block No. 1

Block/Floor/Room	Room Description	Material Location	Product Type	Asbestos Type	Material Assem't Score	Action
1 /0/	Junior Dining Room	Asbestos insulating board beading to fire screen on wood doors (to both sides) to Circulation	Asbestos Insulating Board	Crocidolite (or unknown)	6	No Attention Required - Inspect at Intervals

Description: Asbestos insulating board beading  
to fire screen on wood doors (to both sides)  
to Circulation
